## State of the Environment Report: Wainfleet Bog Ecosystem

Prepared by 8Trees Inc. March 11<sup>th</sup>, 2024.

The purpose of this report is to assess the state of the environment as determined by the population trends of species at risk reptiles affected by the ecological trap (CPA) and the quality of refugia habitat represented by the provincial conservation reserve, Area of Natural and Scientific Interest (ANSI).

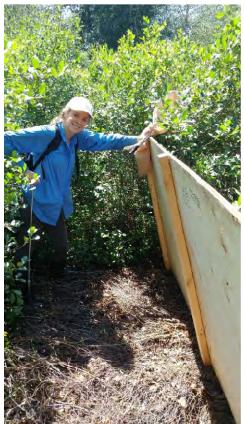
Photo 3: Left. ANSI Low Shrub area is now a tall shrub area by Aug 10, 2016 same area as previous.

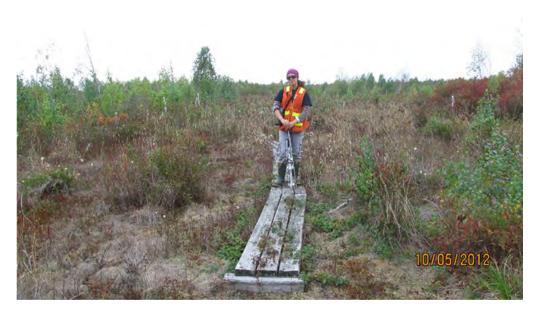
Photo 19: CPA, West Beaver Pond Oct 2012, post drainage. Note desiccated sphagnum at surface.

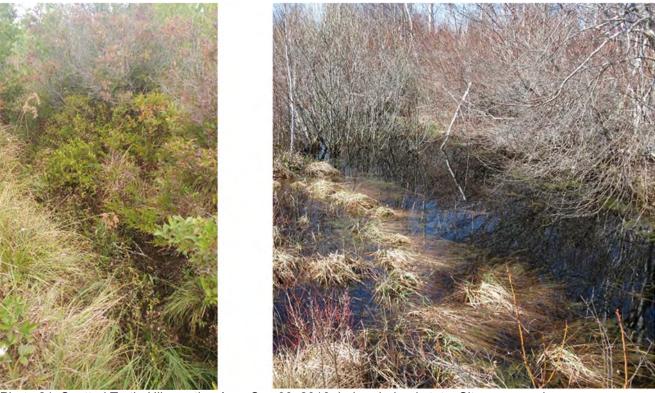
Photo 21: Spotted Turtle Hibernation Area Sep 30, 2016 during drained state. Site was popular hibernation area before 2016. Photo 22 (Right) same hibernation area taken March 26, 2010.

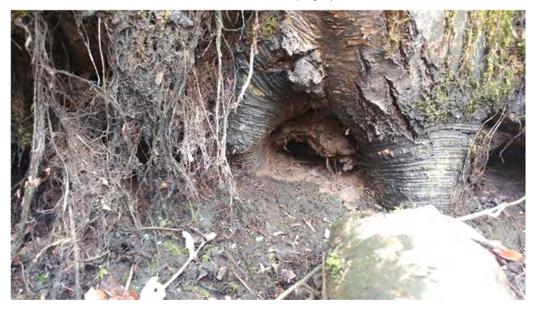
Photo 23: Spotted Turtle Hibernation areas open and exposed in the banks of ditches within CPA. Sep 30 2016; during drained state no water post wildfire season.

Turtles overwinter inside a burrow within the banks of interior ditches within the CPA (PHOTO 29). From annual mark-recapture studies, not all ditches contain overwintering turtles. Midwinter water quality assessments indicate the highest dissolved oxygen and coldest temperatures (<0°C) are just below the ice surface and the poorest oxygen (< 2mg/L) and warmest temperatures (4–5° C) are in the bottom of the ditches (Yagi and Yagi, 2018). In a dried-down state, traditional Spotted Turtle hibernation areas have depleted or no surface water with groundwater if present close to the bottom clay layer. Turtles are either displaced to alternate sites or they attempt to hibernate in their traditional sites. If they remain close to the surface without the protection of groundwater, they risk mortality by freezing, alternatively they may dig down to the ground water table and they may asphyxiate. Water level increases overwinter should benefit turtles however water level depletions will harm turtles. In either scenario depending on their initial depth, turtles would need to reposition themselves within the burrow to maintain the best water quality. Furthermore, fast movement by reptiles during cold temperatures  $(< 5^{\circ}C)$  is unusual requiring arousal and increased energy use. Overwinter mortality of adult turtles (Spotted Turtles, Snapping Turtles, and Midland Painted Turtles) is a regular occurrence of a few animals per winter. Overwinter mortality is evidence that the CPA is not supporting the ecological function of hibernation and is an ecological trap for turtles.

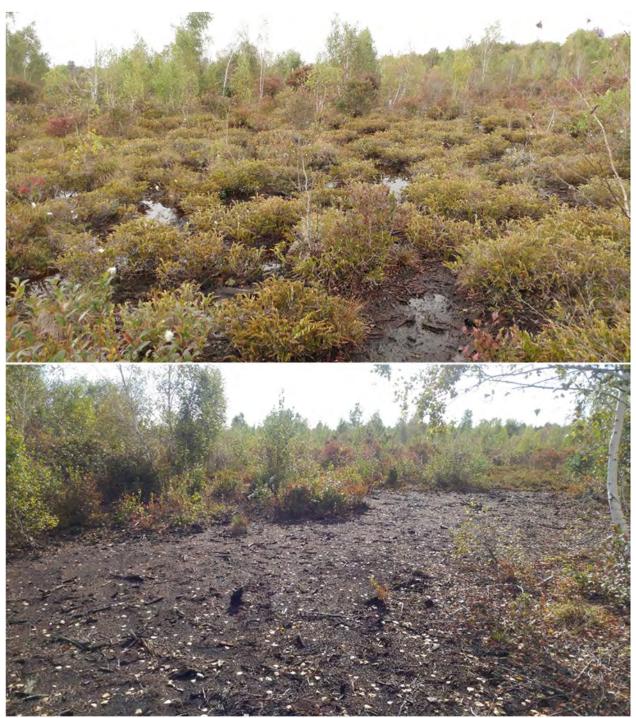
Photo 28 and 29: Oct 3, 2018 CPA area West of main trail south of the northern most ditch. Top showing low shrub community and Bottom showing saturated peat conditions. These areas dry out in summer months and the surface of the ground becomes dusty.

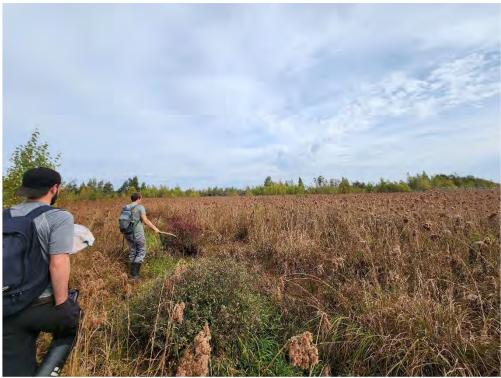
Photo 32: CPA increasing marsh characteristics. Site is dry Oct 6, 2022.

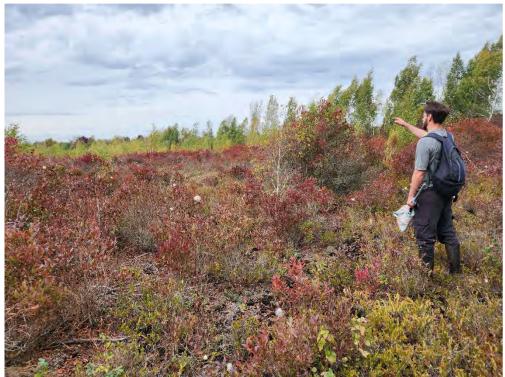
Photo 33; CPA Same Are as photo 27. Site is Dry Oct 6, 2022

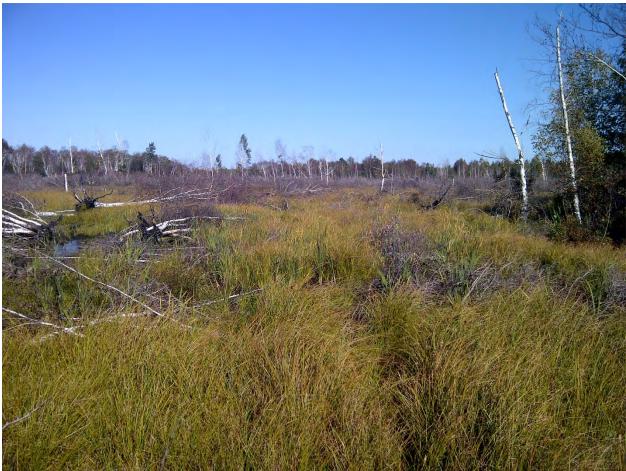
Photo 41. CPA Note European White birch has fallen following the 2006 to 2010 extended high water level period. Photo taken Sep 24, 2013

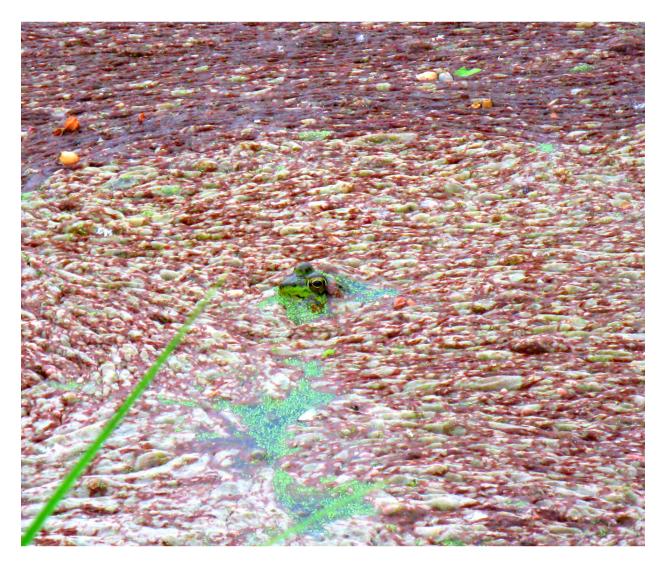
Photo 42. Evidence of water quality impairment extensive red-green algae blooms in CPA May, 2010.

Finally, we recommend using the Society for Ecological Restoration methods for assessing restoration progress. Criteria for water quality, nutrients, pH, have not been developed but indirectly relate to the population trends being observed especially for Spotted Turtle (Photo 42 and 43).
